ASE PAPER

⑥ SHIP ELECTRONIC SYSTEM DEGRADATION ✓

⑩ Clyde E. Gartley, Jr

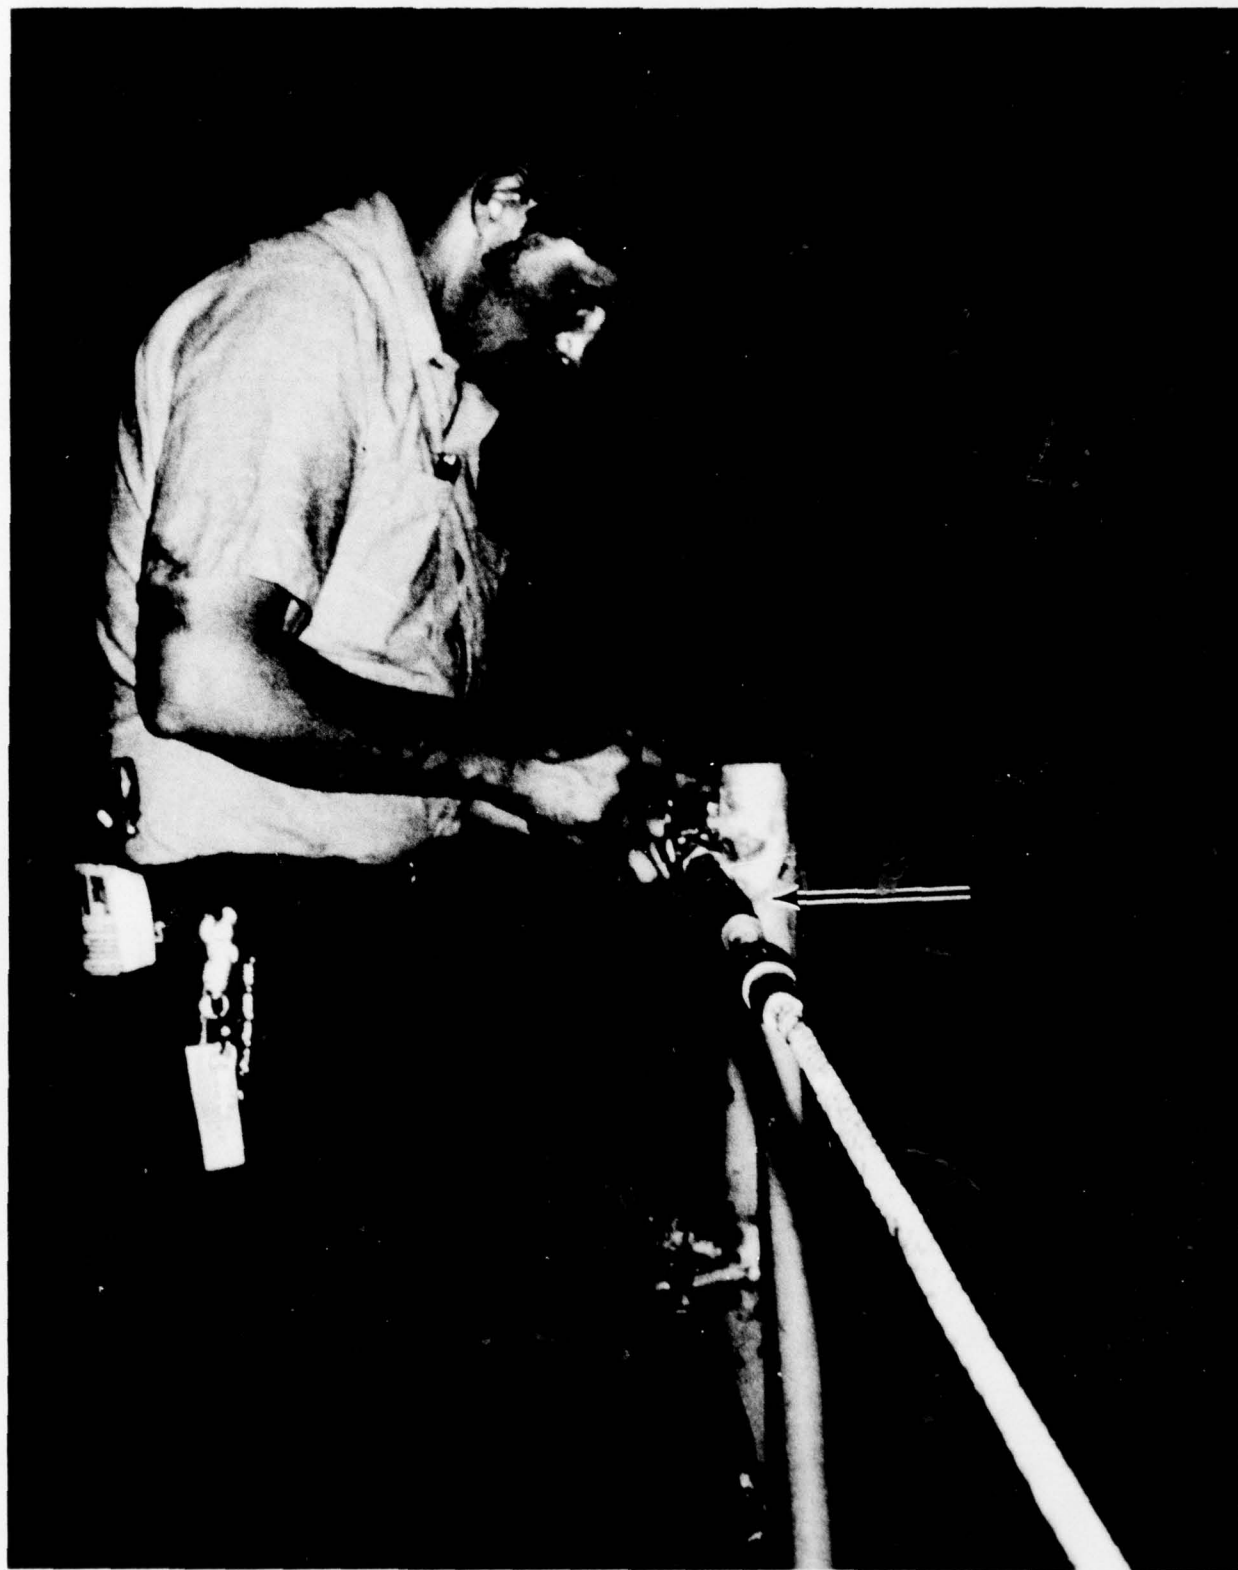
FIG. 10 LIFE LINES, SISTER HOOKS, AND TURNBUCKLES WHICH
FORM NON-LINEAR JUNCTIONS THAT GENERATE IMI PRODUCTS

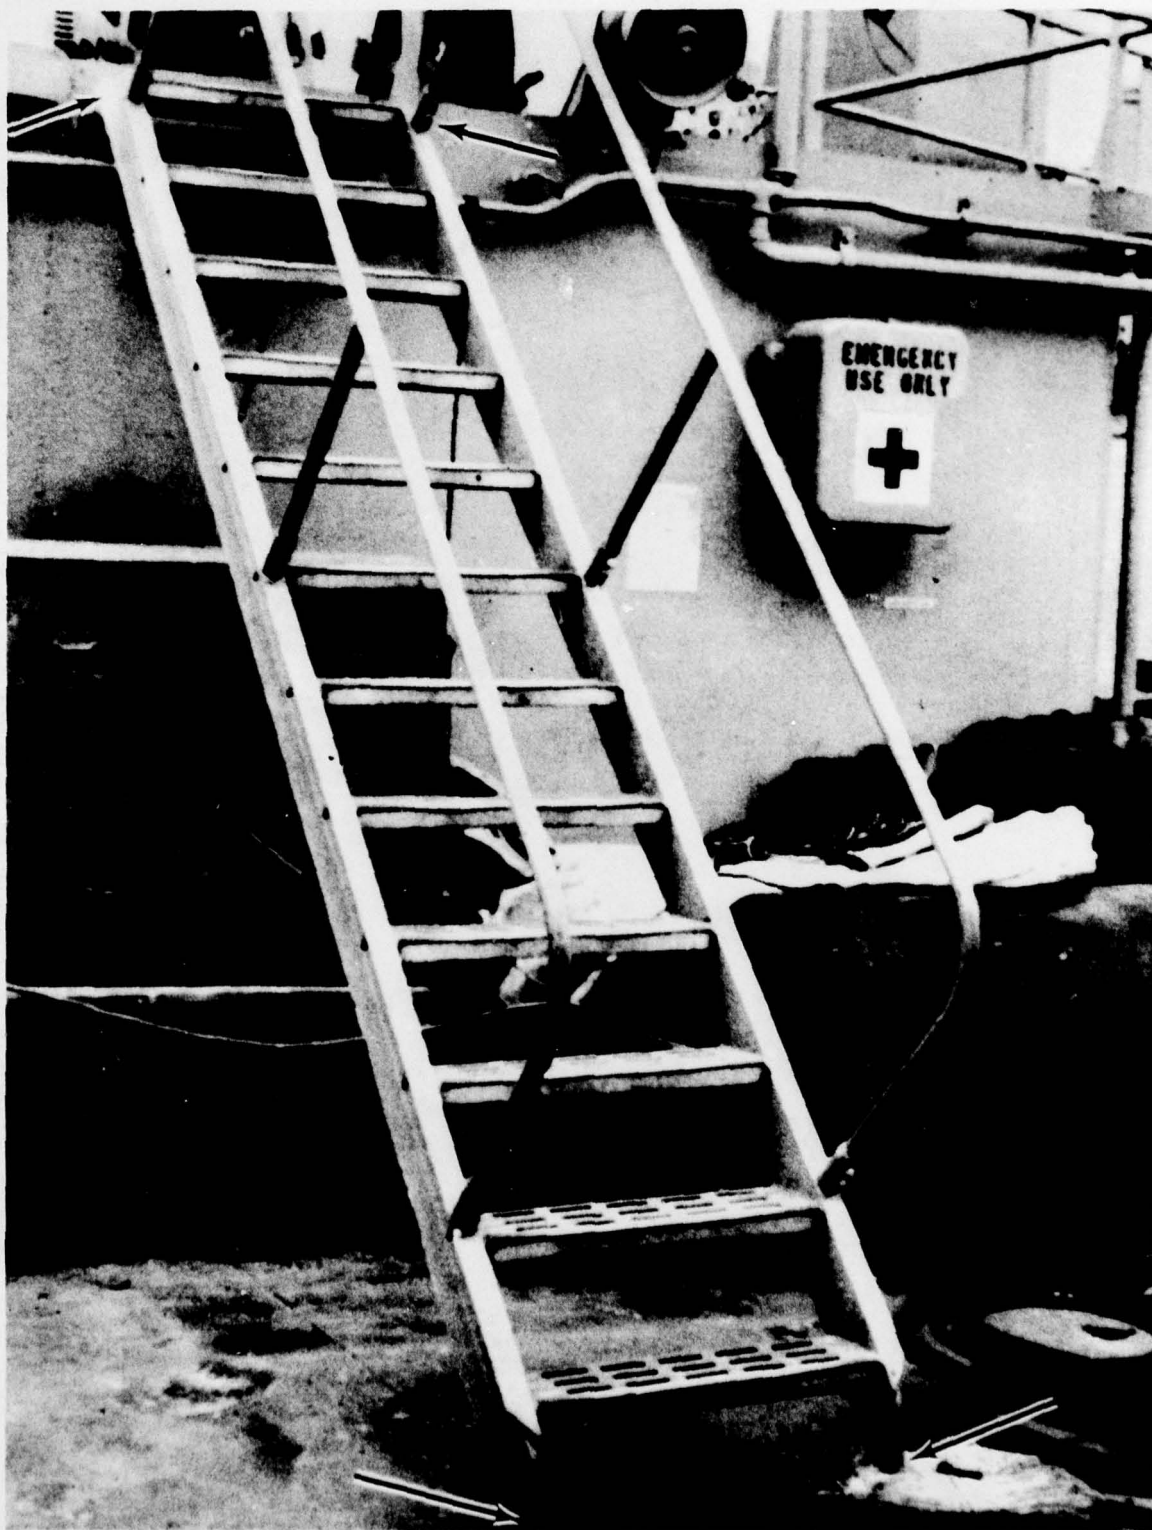
FIG. 11 INCLINED LADDER - TOGGLE BOLTS, WHERE LADDER MATES TO DECK, FORM NON-LINEAR JUNCTIONS THAT GENERATE IMI PRODUCTS
